Shoreline Characteristics Analysis

for determination of desired future conditions in Jamaica Bay Gateway National Recreation Area
National Parks Service, Jamaica Bay Unit

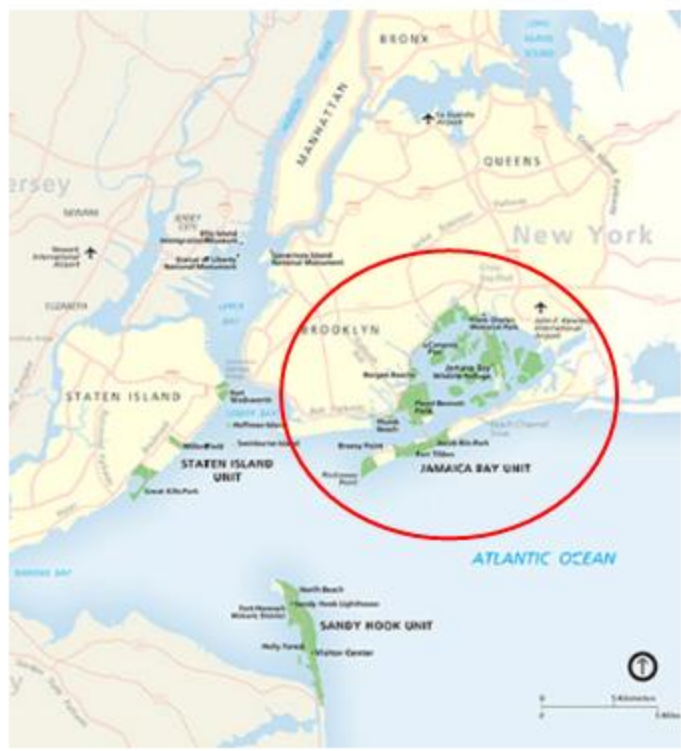
Shoreline Characteristics

- Developed Residential Beach
- Bridge
- Commercial
- Dock
- Lawn
- Mosquito Ditch
- Natural Sand Beach
- Natural Vegetated Area
- Other
- Parking Lot
- Paved Road
- Pier
- Recreation
- Residence
- RipRap in Developed Area
- RipRap in Vegetated Area
- Rock Bulkhead in Developed Area
- Rock Bulkhead in Vegetated Area
- Dirt Road
- Steel or Concrete Bulkhead in Developed Area
- Steel or Concrete Bulkhead in Vegetated Area
- Lighthouse or Lifeguard Tower

The white boundary delimits the Jamaica Bay Unit of the Gateway National Recreation Area

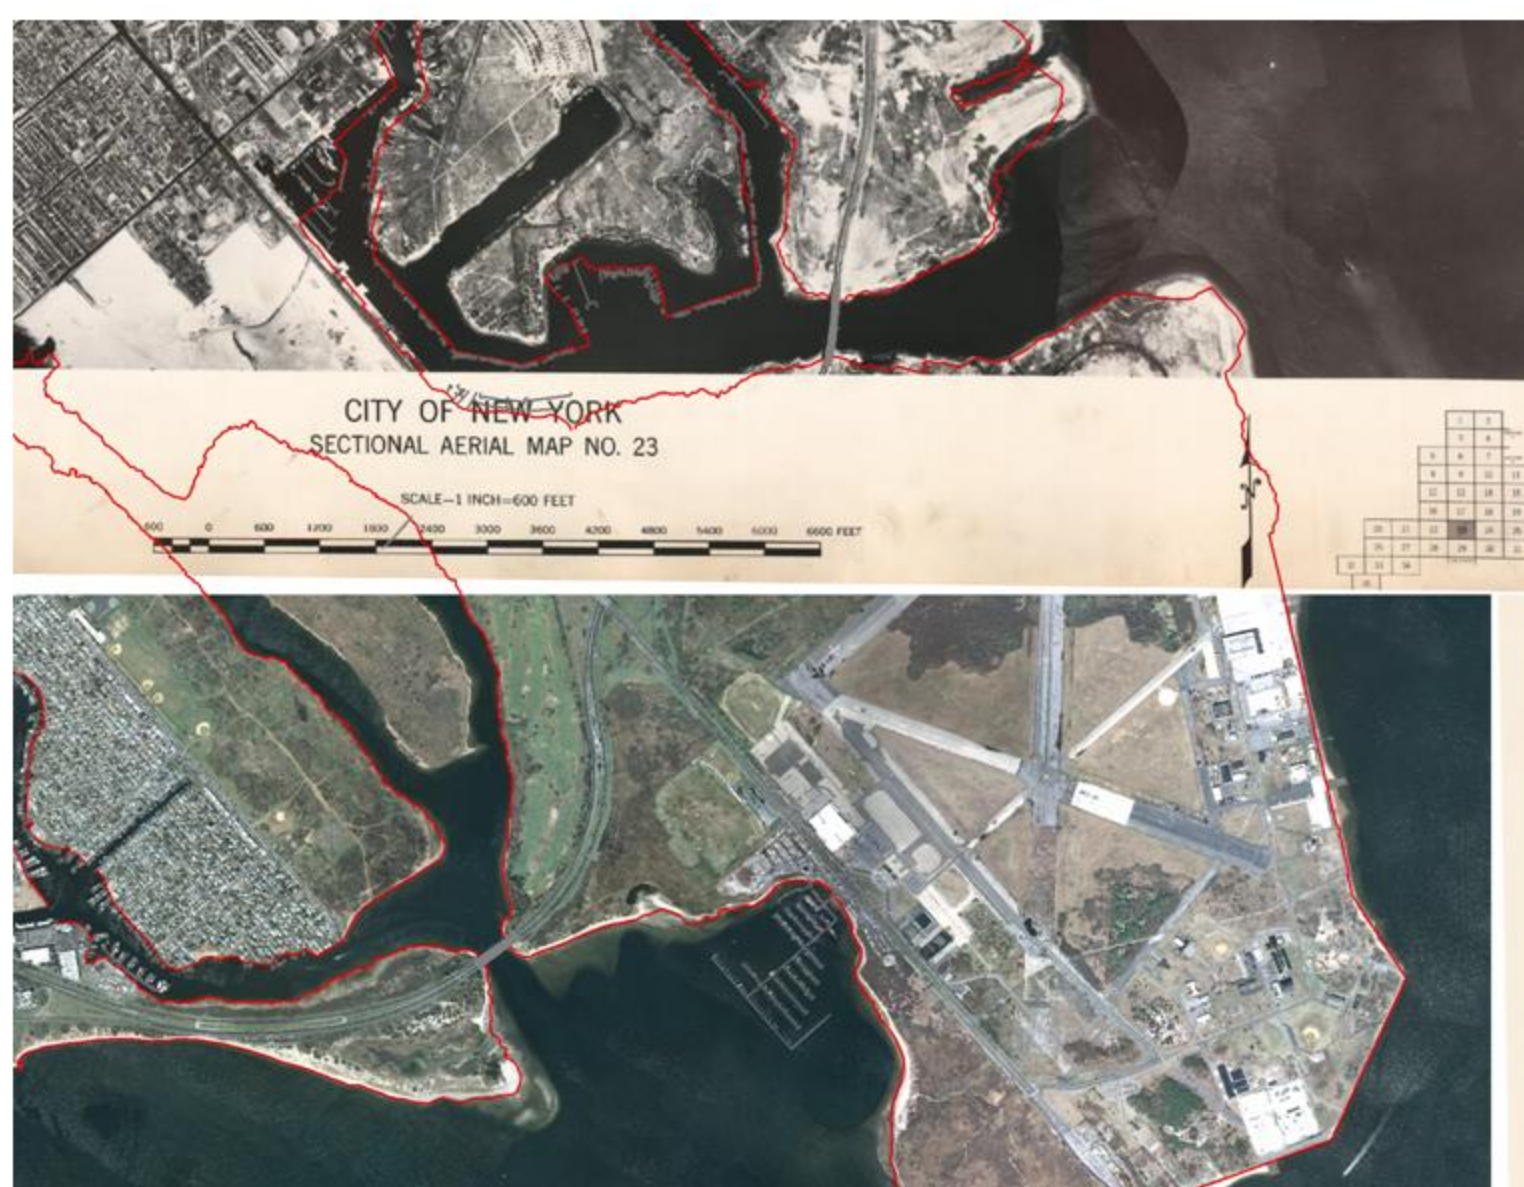
Georeferenced image from the 1950s laid over the 2006 satellite image of Floyd Bennett Field.

In the 1950s, New York City commissioned a series of high definition aerial photos of the entire urban region. The photos for the Jamaica Bay section are being compared to current satellite imagery in order to analyze shoreline characteristics and help determine desired conditions for the Jamaica Bay.

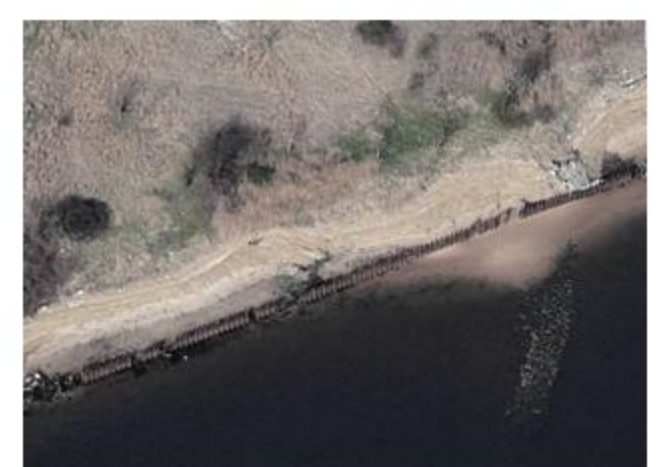
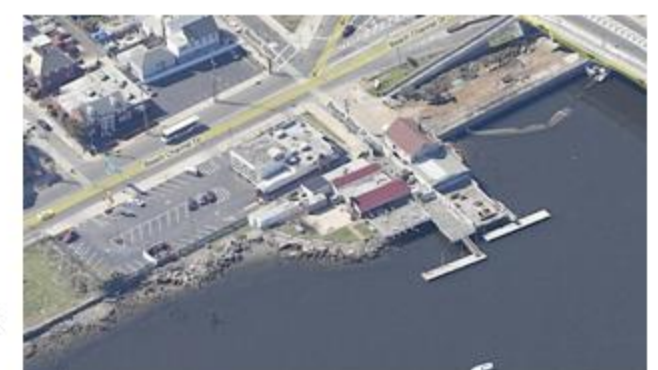
Potential reclamation site (above) and typical shoreline condition (below).

The shoreline of Jamaica Bay (including Broad Channel Island) and its primary creeks is roughly 60% natural and 40% human-modified (see table above for exact figures). The majority (roughly 70%) of the natural coastline contains vegetation with the remainder comprised of sand beaches. It is important to keep in mind, though, that these natural shorelines often do not extend back very far before reaching developed areas. The majority (roughly 60%) of the human-modified areas are comprised of structures (mostly residential and commercial) built directly on the shoreline, with the remainder mostly comprised of bulkheads in front of developed areas. This analysis is being used to identify priority sites for hardened shoreline reclamation in short and long term plans for the bay.
